Paint Stripping Trial
March 2, 2007
Kevin Brubaker and Jason Brubaker
(Report prepared by Michael O. Hunt 3/4/07)

Location: 928 State Street, Lafayette, Indiana 47905. The project is a large, wood-framed and sided, 3 story 1890s Queen Anne house. The house was vacant. It had last been used as an 8 unit rental.

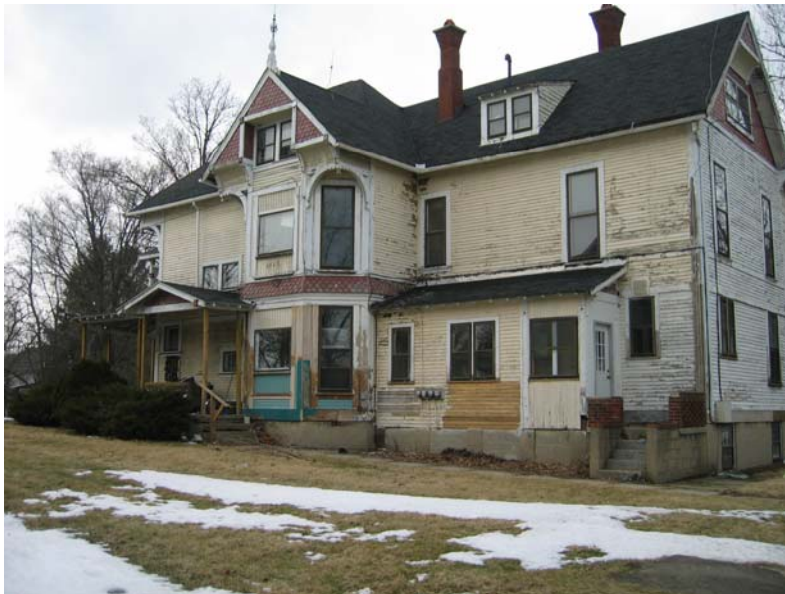
Condition: In general the house was in poor repair. The heavy accumulation of multiple coats of oil-base paint was peeling, flaking and cracking extensively.

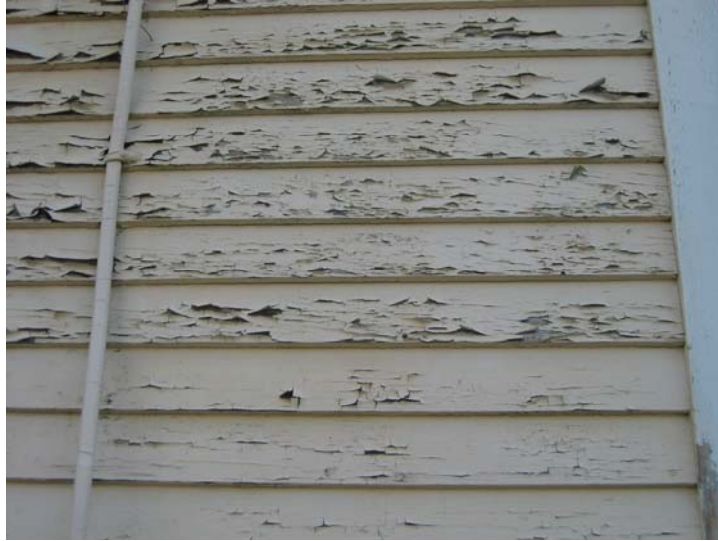
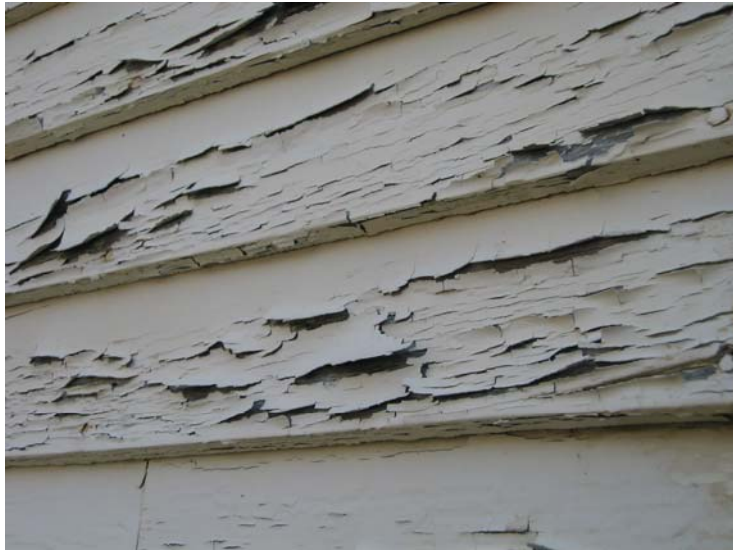
Overall view and close-up views of paint condition

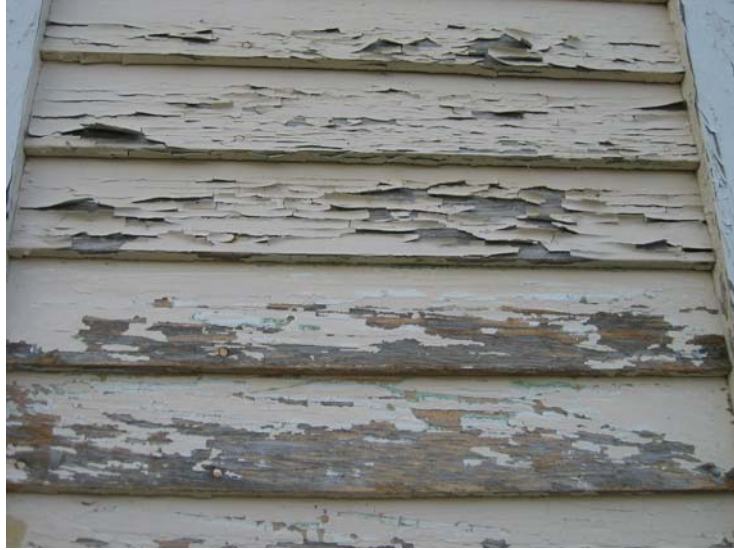
Prior to the Paint Shaver trial the condition of the paint was tested by scraping with carbide-tipped scraper. Flaking and peeling paint was removed, but much intact paint remained. It was apparent that the intact paint would, in time, chip and flake as well.

The bottom two laps were vigorously scraped with carbide tip scrapper.

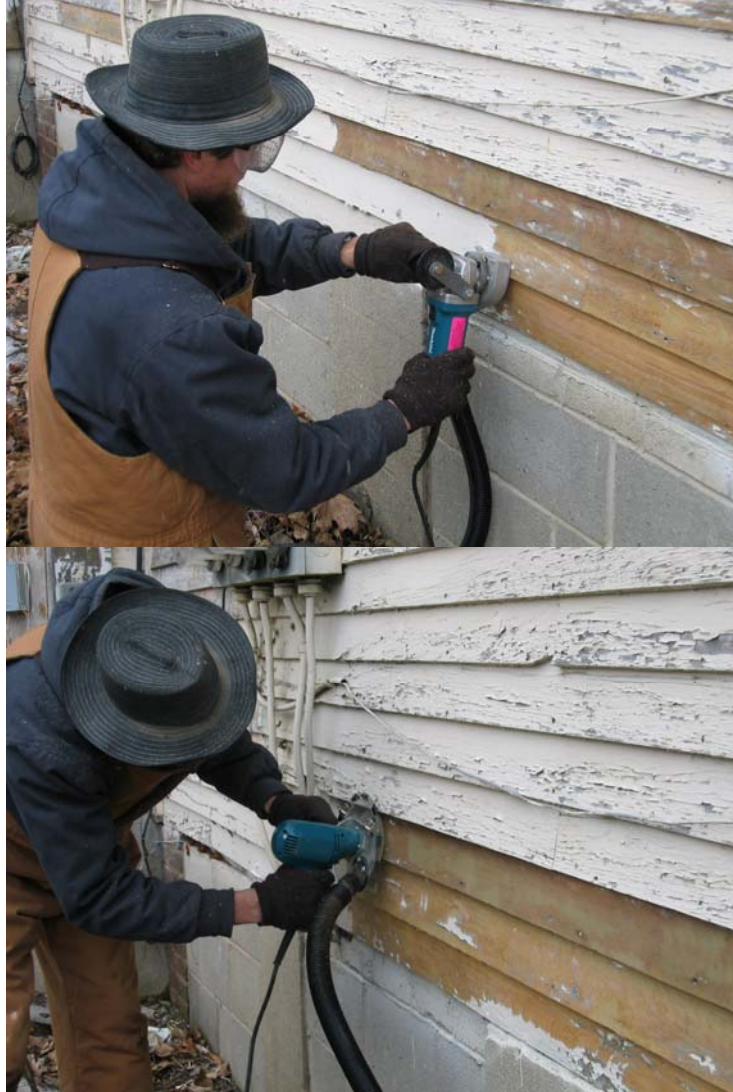
Note: Both the Paint Shaver and 5-inch Mikita disc sander were attached to a shop vac. The sander was equipped with an American International Tool suction head attachment.

Paint Shaver® top and high-speed disc sander with suction head attachment bottom both attached to vacuum

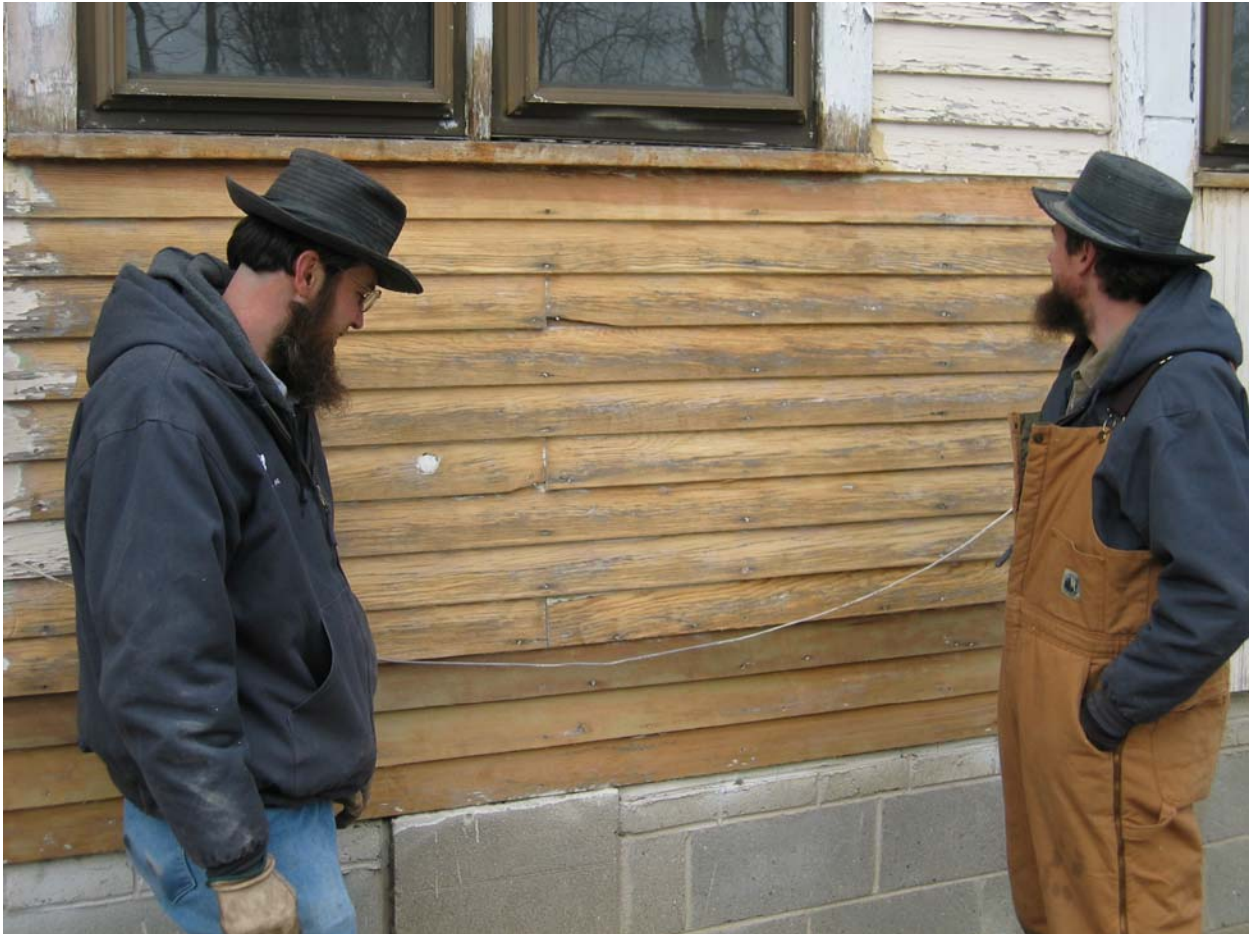
Jason Brubaker and Kevin Brubaker inspecting stripped siding. Note the bottom three laps are yellow poplar and the top nine laps are pine. The stripped siding is now ready for treatment with a paintable water repellent preservative.
